Overtopping Modifications to Tygart Dam

Mark P. Zaitsoff, P.E.¹

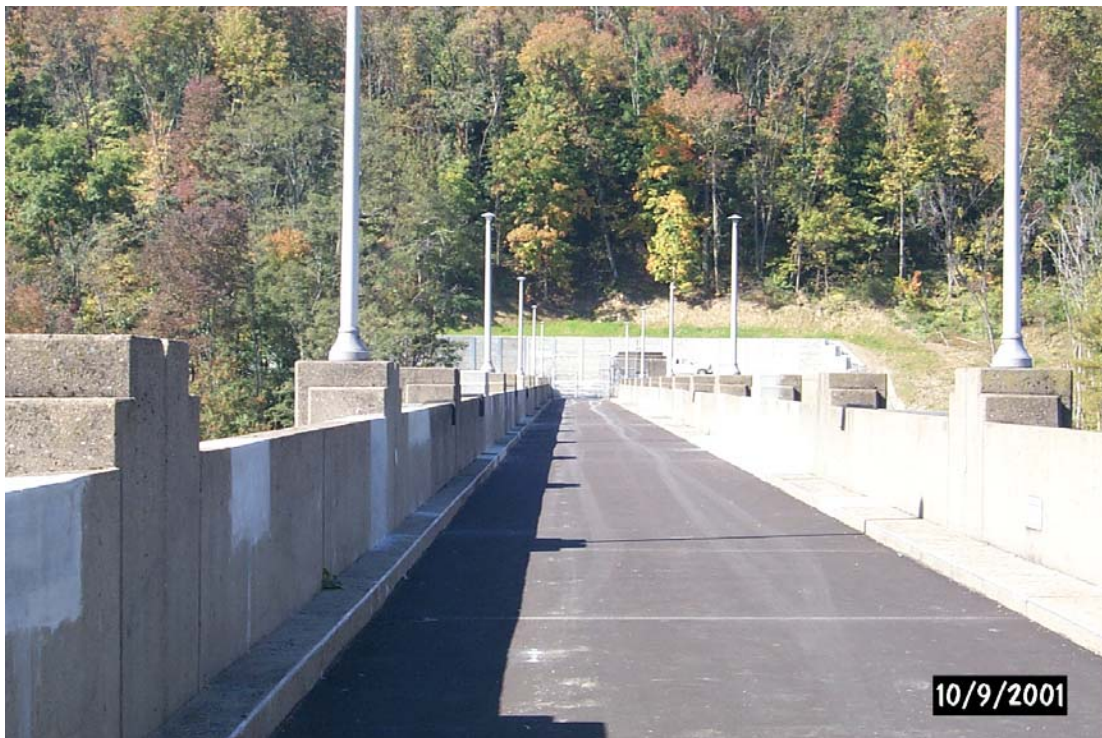
Before the structure overtops the water will backflow through the road drains onto the roadway. When the structure overtops the water will first flow over the upstream parapet wall, completely fill the roadway area and then flow over the downstream wall. Structural analysis showed that the parapet walls were strong enough to withstand the overtopping flow. The deteriorating concrete on the walls was repaired and the roadway resurfaced (Figure 3).

Figure 3. Looking toward west abutment at parapet walls and roadway repairs

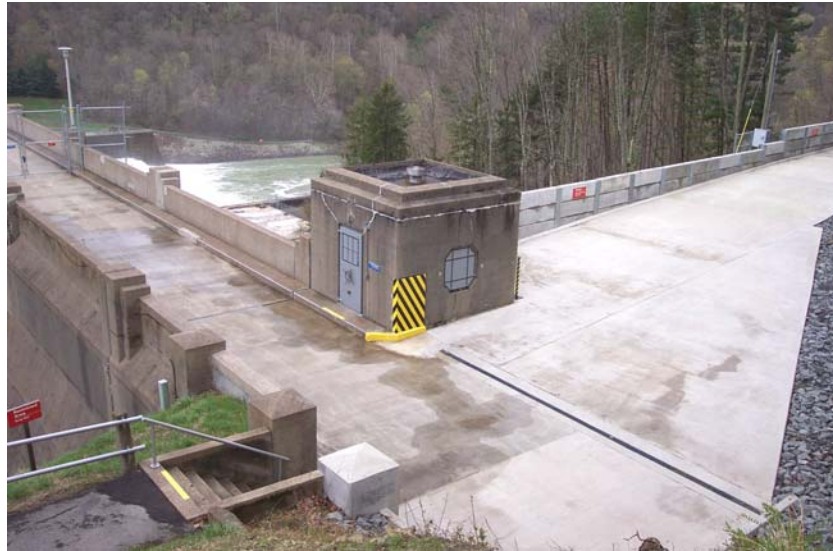
The water that fills the roadway area would flow to each abutment and down them to the toe of the structure. Walls have been added at the downstream side of each abutment to prevent the overtopping flow from flanking the dam (Figure 4).

Figure 4. Wall at east abutment and reconstructed east access road

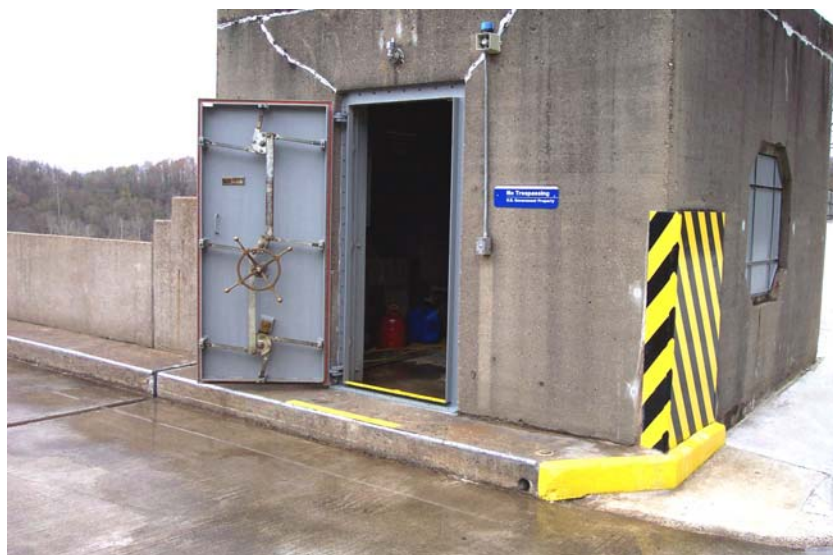
The doors and windows at the top of the structure will be submerged during the overtopping of the structure. The roadway area will be flooded and the top of dam inaccessible for an estimated 21 hours. Failure of a door or window would allow the water to flood the interior of the structure possibly leaving the dam inoperable for an extended period of time. All doors and windows, below the overtopping elevation, have been replaced with watertight units or provided with watertight covers (Figure 5).

Figure 5. Watertight door and window in the east stairway building

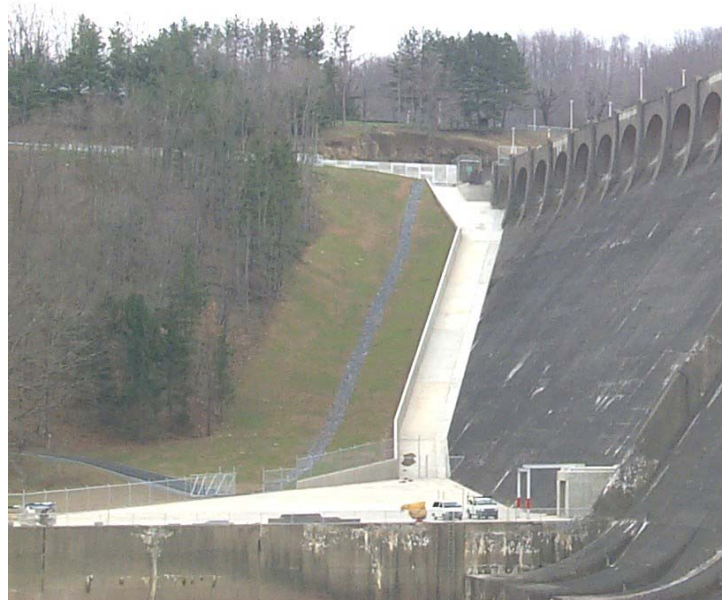
The overtopping flow will plunge over the downstream parapet wall onto the downstream face of the dam. Concrete channels and paving have been constructed to guide the high velocity overtopping flows down each abutment slope into the stilling basin and river channel and to protect the downstream toe of the structure (Figures 6 and 7). The channels vary from 30 feet wide and 5.5 feet deep at the top of the slope to 80 feet wide and 8 feet deep at the bottom. The flat areas at the toe of the structure have been paved to the extent of the stilling basin walls; stone protection was considered but would have limited access to the toe of the structure.

Figure 6. Concrete paving and channel on east abutment

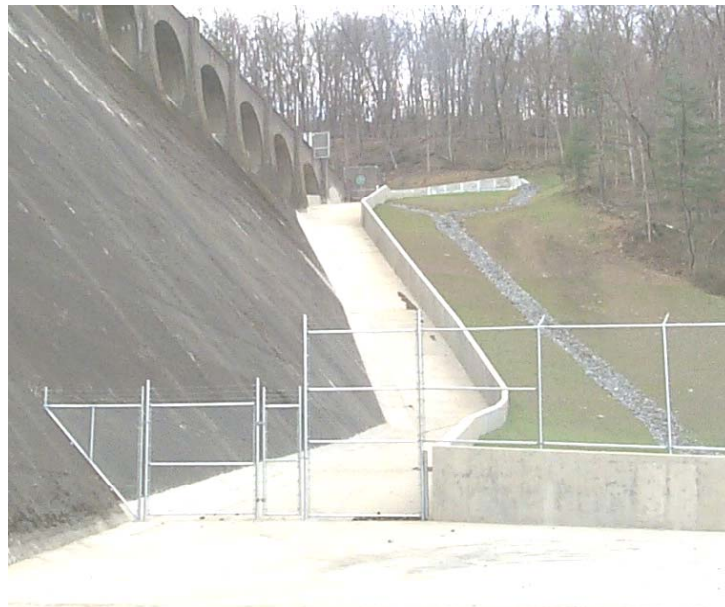
Figure 7. Concrete paving and channel on west abutment

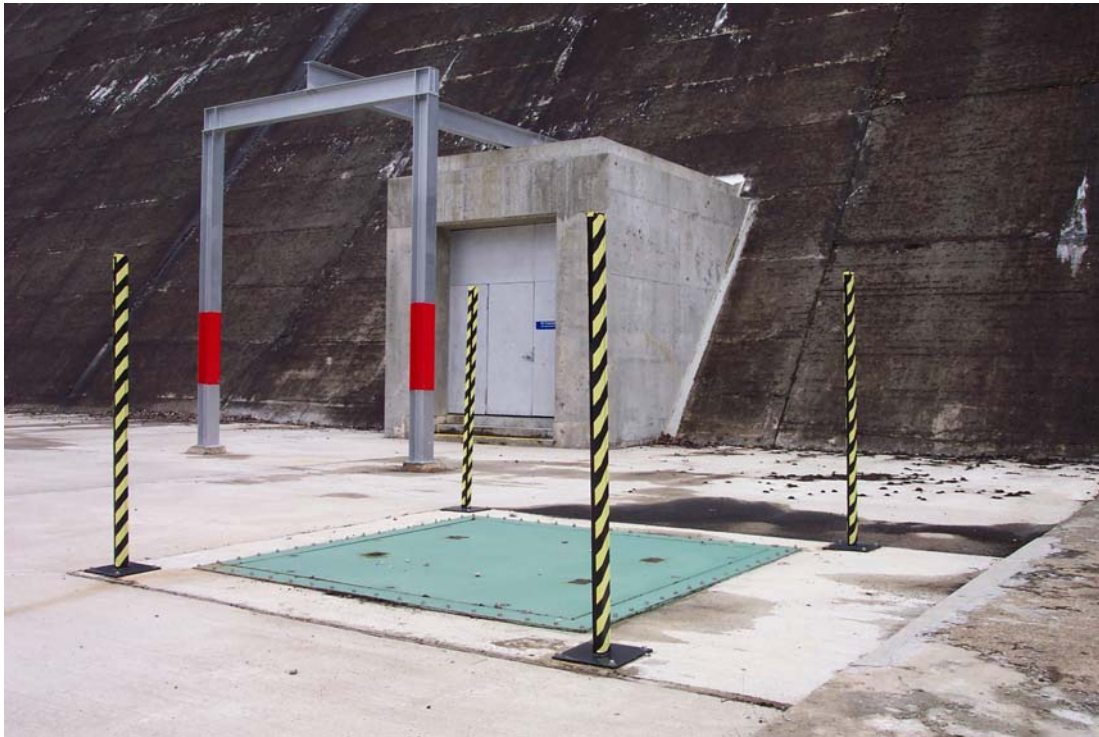
The two adits at the toe of the structure, which provide access to the operating gallery, will be impacted by the overtopping flow and submerged by the PMF tailwater for an estimated 20 hours. Failure of an adit would lead to the flooding of the operating and lower galleries with resultant damage to the sluice and ring jet controls. The adits were rebuilt to withstand the overtopping flow's impact and provided with watertight doors while maintaining the historically significant architecture of the structure. Access galleries to the low flow ring jet valves were provided with watertight hatches (Figure 8).

Figure 8. Reconstructed east adit and access hatch to ring jet valve

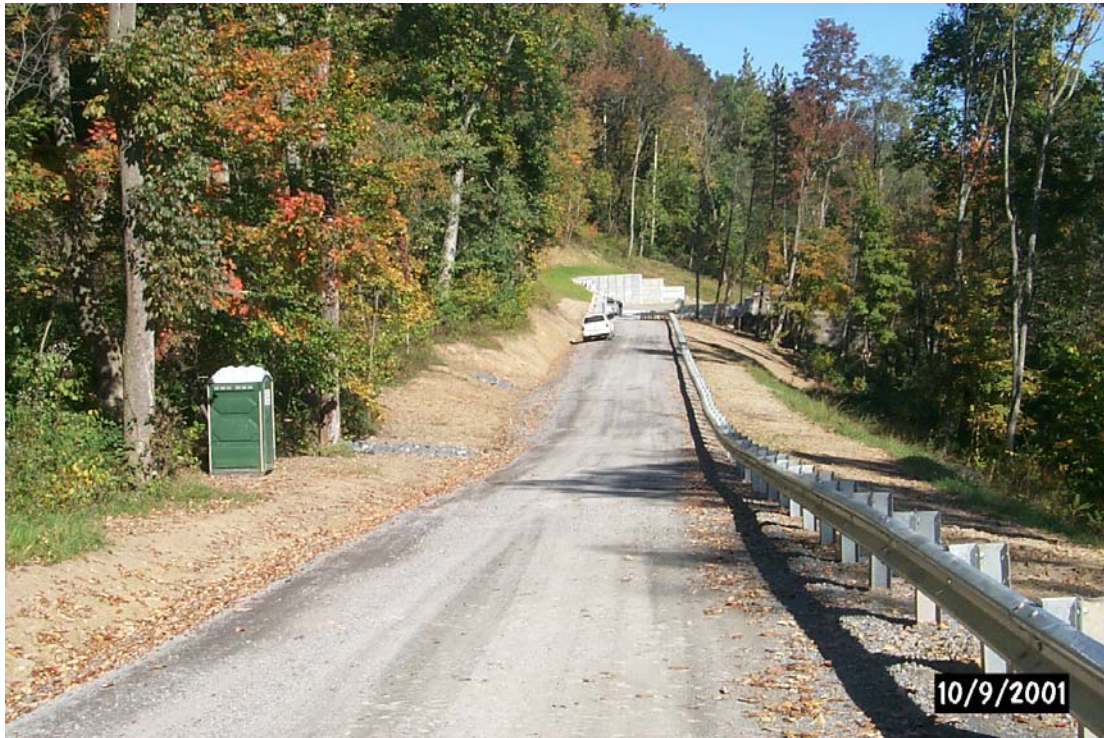
An additional feature of the project was the construction of an access road to the west abutment. There had been no vehicular access to the west abutment since the dam was completed in 1938; the only access was by walking through the dam galleries or by climbing up the west abutment slope from the toe of the dam. A new road was built to provide access during construction and for future maintenance access (Figure 9).

Figure 9. West access road looking toward west abutment
